Failures of Engine Bearings and their Prevention

Dr. Dmitri Kopeliovich

Smooth Sliding (Owner)

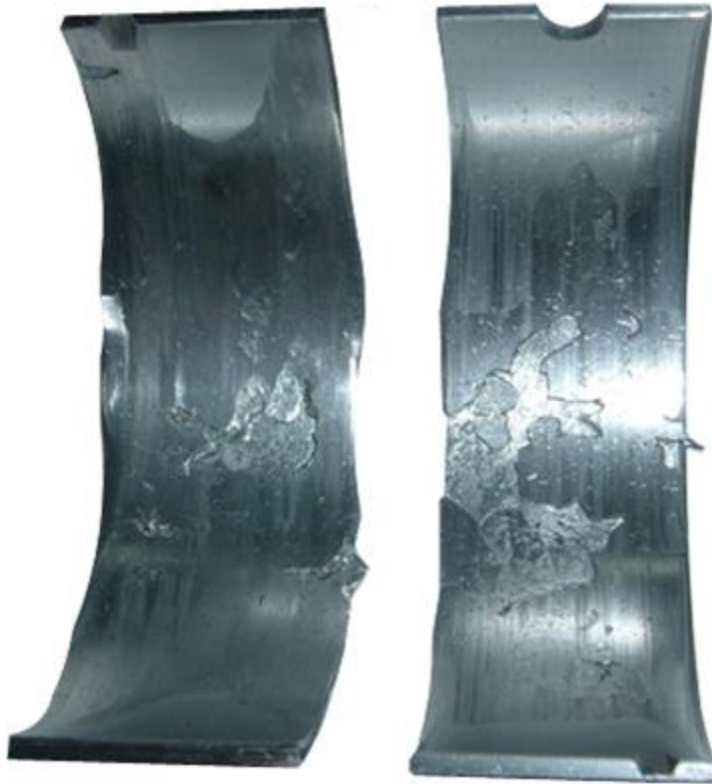
Fig.1 Fatigue of Aluminum Lining

Fatigue of an aluminum lining appears in form of cracks, cratered and distressed bearing surface due to loss of the lining material. It may also cause extrusion of the lining material out of the bearing edges.

- Select a bearing material with higher load capacity
- Check: oil clearance and component geometry
- Retard ignition or use fuel with higher octane number
- Repair/replace distorted parts

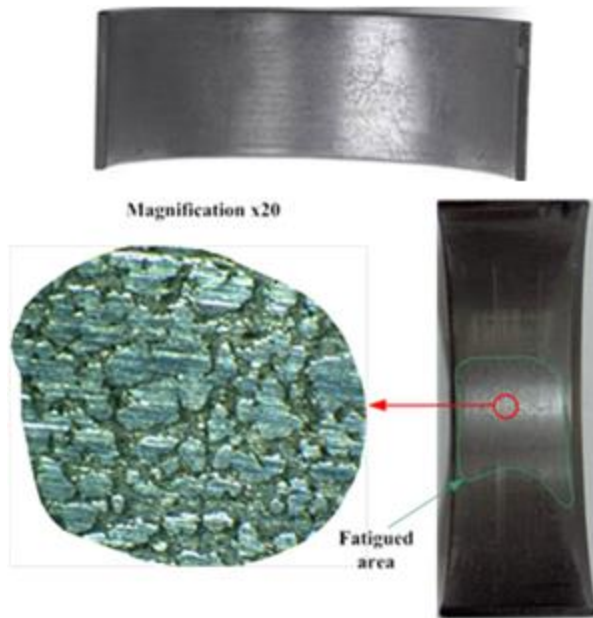
Fig.2 Fatigue of Babbitt Overlay

Fatigue of an overlay results in formation of irregular spider web-like cracks and craters in the overlay surface. It may lead to partial flaking of the overlay followed by fatigue of the copper base intermediate layer.

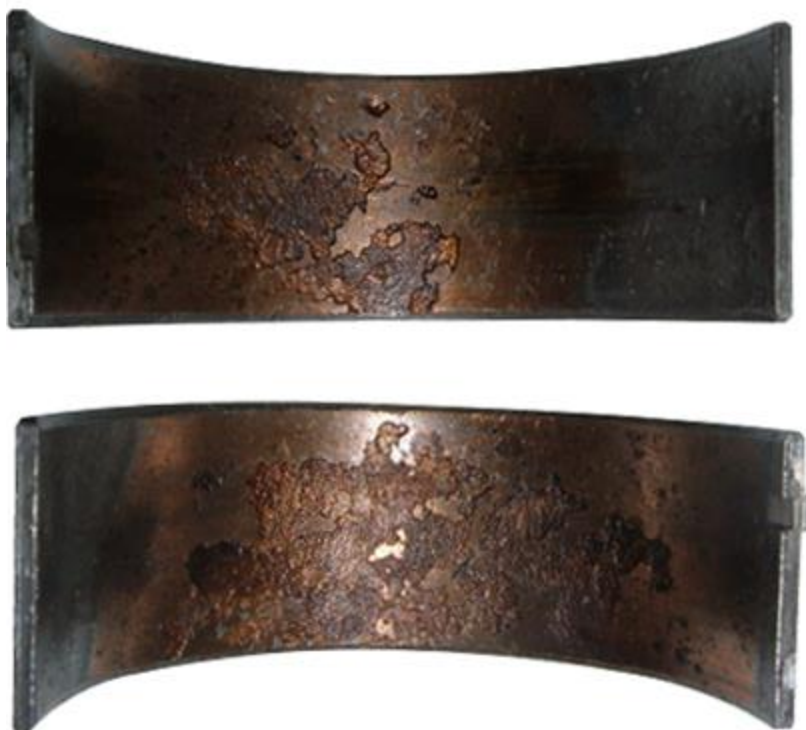
Fig.3 Fatigue of Bronze Intermediate Layer

It appears in babbitt surface missing and intermediate layer cracked and cratered. Fragments of the bronze material are detached from the steel back causing imminent bearing failure.

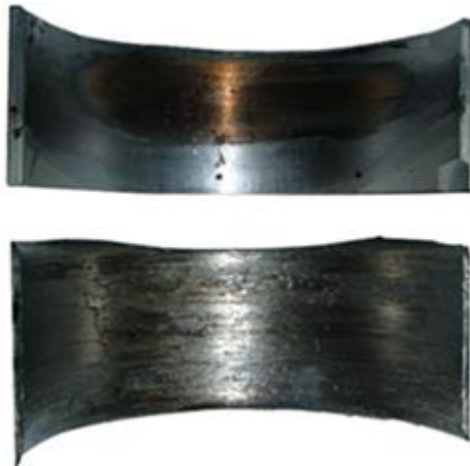
Fig.4 Surface Wear

Wear of the bearing material is commonly a result of metal-to-metal contact between the bearing and the journal surfaces. Surface wear may appear in the following types:

- Accelerated wear - shiny surface
- Heavy wear - signs of overheating (blackening), partial melting/removal of overlay (Fig.2, top shell)
- Severe wear - torn surface, heavy overheating, melted/missing overlay and lining material (Fig.2, bottom shell)

- Insufficient oil supply (oil starvation)
- Non-uniform/unstable oil film (due to bearing fatigue)
- Geometrical irregularities or poor journal surface finish
- Grinding chatter marks and lobbing
- Contaminated oil

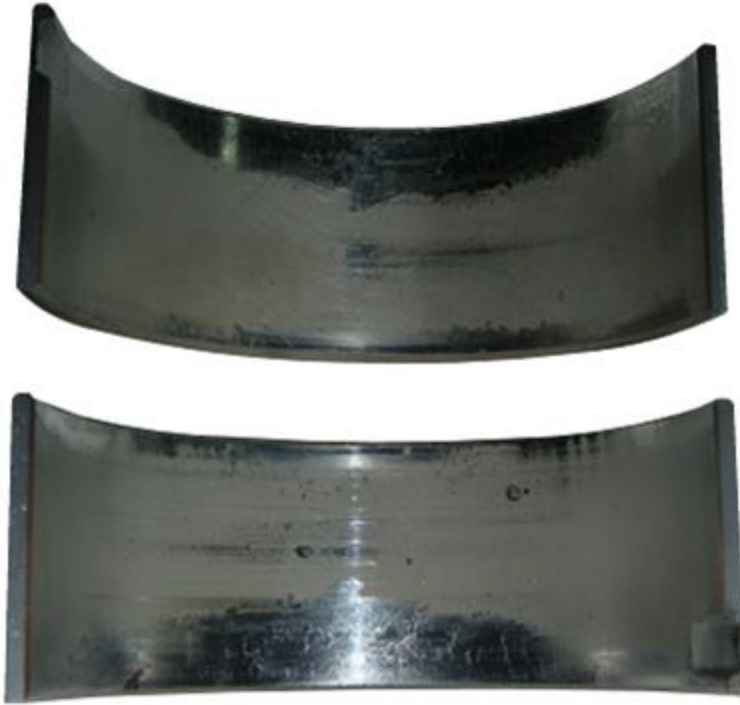
Fig.5 Edge Wear due to Distorted Connecting Rod

Distorted (bent or twisted) connecting rod is one of the causes of localized loading of engine bearings resulting in excessive wear of the bearing surface along the bearing edge. fatigue cracks may also form in the affected area.

- Overloading
- Detonation
- Excessive torque

Distorted rod produces non-parallel orientation of the bearing and journal surfaces. Metal-to-metal contact occurs along the bearing edge.

- Replace the distorted parts
- Prevent engine detonation and pre-ignition (check cooling system, air-fuel ratio, ignition timing, knock sensor, octane number of fuel)
- Choose higher strength connecting rods

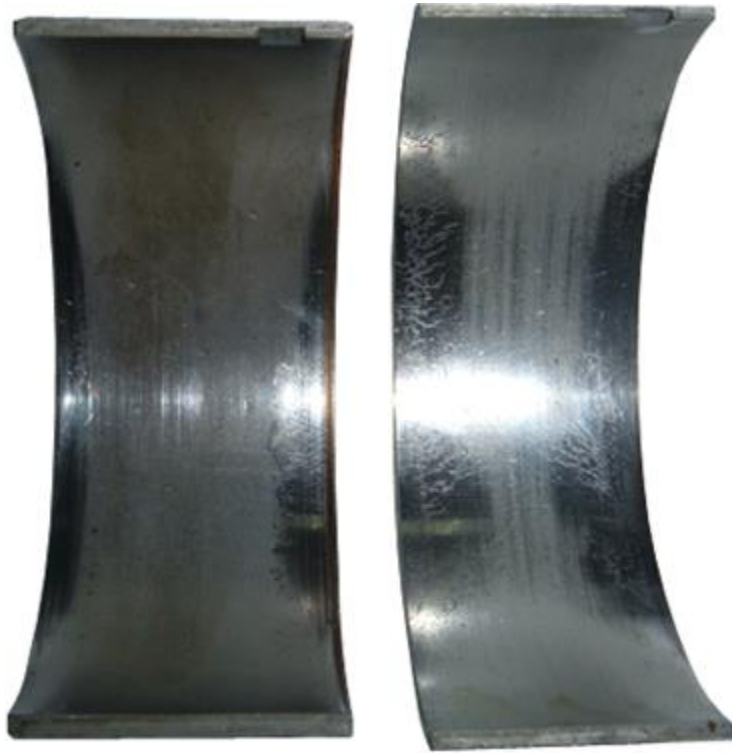
Fig.6 Local Wear due to Imperfect Journal Geometry

Imperfect journal geometry is a cause of localized loading of engine bearings which results in wear in parts of the bearing surface. Due to local overloading fatigue cracks may occur in these areas.

- Inconsistent journal diameter. Areas of greater diameter produce metal-to-metal contact with the bearing surface, causing local wear.
- Use of worn or improperly dressed grinding wheel when resizing the crankshaft. Shaft grinding may result in tapered, hourglass shape or barrel shape.

- Replace/redress grinding wheel
- Re-grind the crankshaft

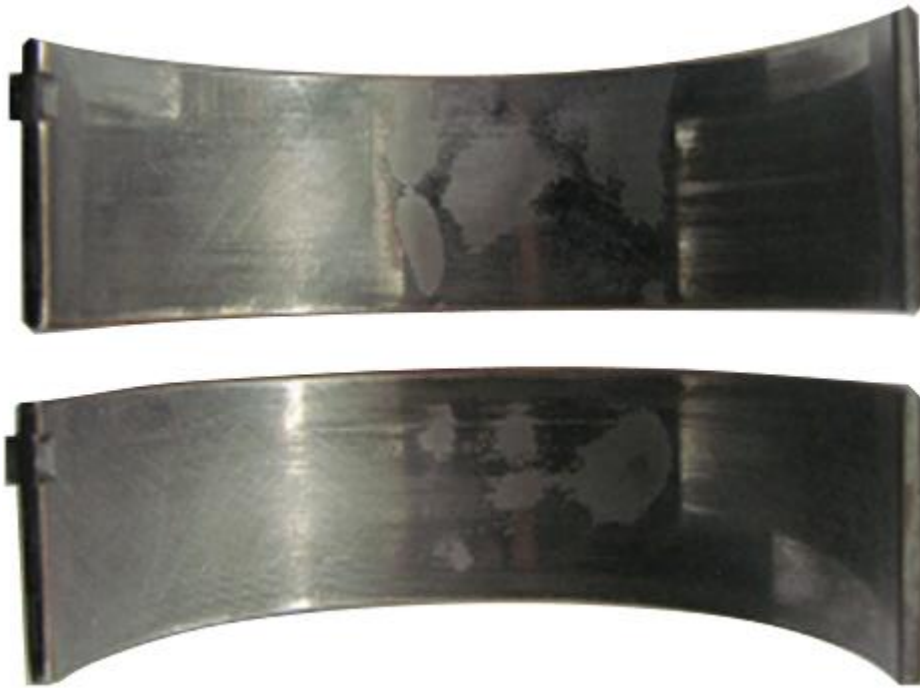
Fig.7 Cavitation Erosion

Cavitation erosion appears in damaged areas on the overlay due to sharp changes of pressure in the oil film.

Cavitation erosion of bearing material is formed by the following mechanism: Vapor cavities (bubbles) in the oil – when the load applied to a bearing fluctuates at high frequency (high RPM). The oil pressure can instantly fall, causing vapor cavities (bubbles) due to fast evaporation (boiling). When the pressure rises, vapor cavities (cavitation bubbles) contract at high velocity. Such collapse results in impact pressure, that can erode the bearing material.

- Select stronger (harder) bearing material
- Decrease oil clearance
- Avoid running the engine at extremely high rotation speeds

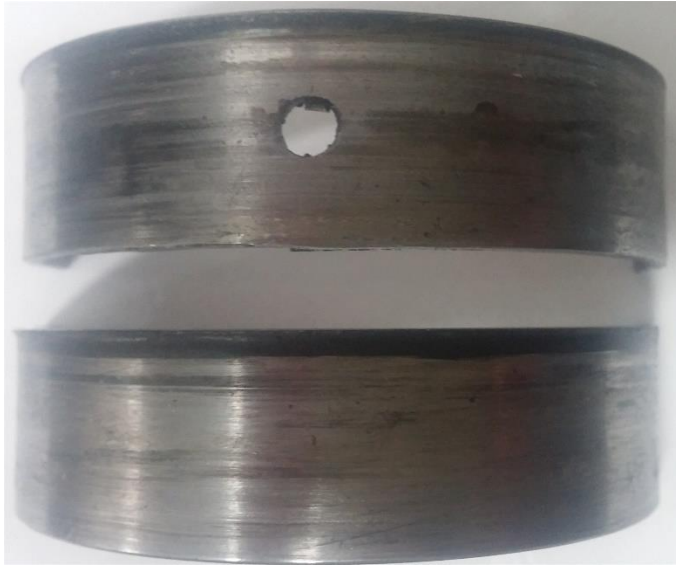
Fig.8 Spinning of Bearing in Housing

The indication of this failure is highly polished area on the bearing back caused by bearing spinning in the housing.

- Insufficient crush height
- Oil starvation/lugging the engine causing seizure
- Housing diameter is greater than specified value

- Choose bearings with sufficient crush height for the application
- Eliminate the cause of seizure
- Check housing diameter for size and roundness
- Tighten bolts to the specified torque value

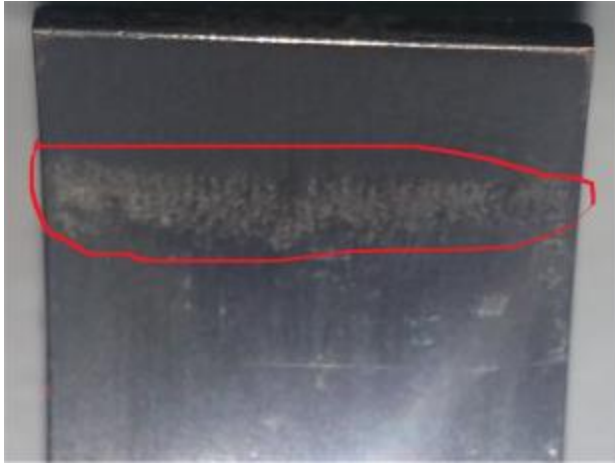
Fig.9 Fatigue in Crush Relief Area

This type of the bearing distress appears in form of fatigue cracks in the area of crush relief.

- Excessive crush height - upon torquing the housing, the parting line region of the bearings deflects inward. This reduces the gap between the journal and bearing surfaces. Such change of bearing profile at the parting line region produces localized peak oil film pressure, which can cause fatigue of the bearing material.
- Excessive RPM producing rod bore stretch

- Prevent excessive crush height
- Check the housing diameter
- Avoid over-torquing the rods
- Choose more rigid connecting rods

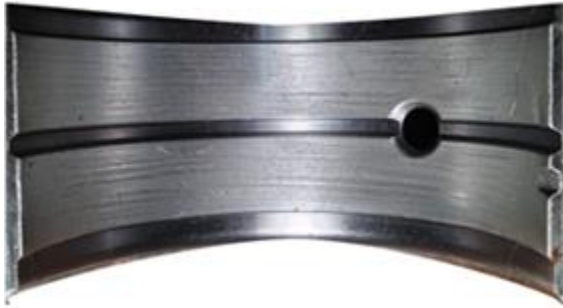
Fig.10 Damage Caused by Foreign Particles

Foreign particles circulating in oil may enter the gap between the bearing and journal and produce abrasive wear in form of circumferential scores or scratches on the bearing surface.

- Particles of grinding abrasive entrapped in crankshaft oil passages and/or other engine block components
- Ambient dirt, sand or dust
- Metal particles (e.g. fragments of fatigued material from failed components)

- Find the origin of the abrasive particles and other contaminants
- Replace air filter, oil and oil filter
- Check crankshaft oil passages and all engine components. Thoroughly clean them with hot soapy water prior to assembly.
